Solving Cleanup Challenges Through Risk Reduction

Cleanup Progress at the Paducah Gaseous Diffusion Plant

Briefing for the
Paducah Citizens
Advisory Board
January 15, 2009

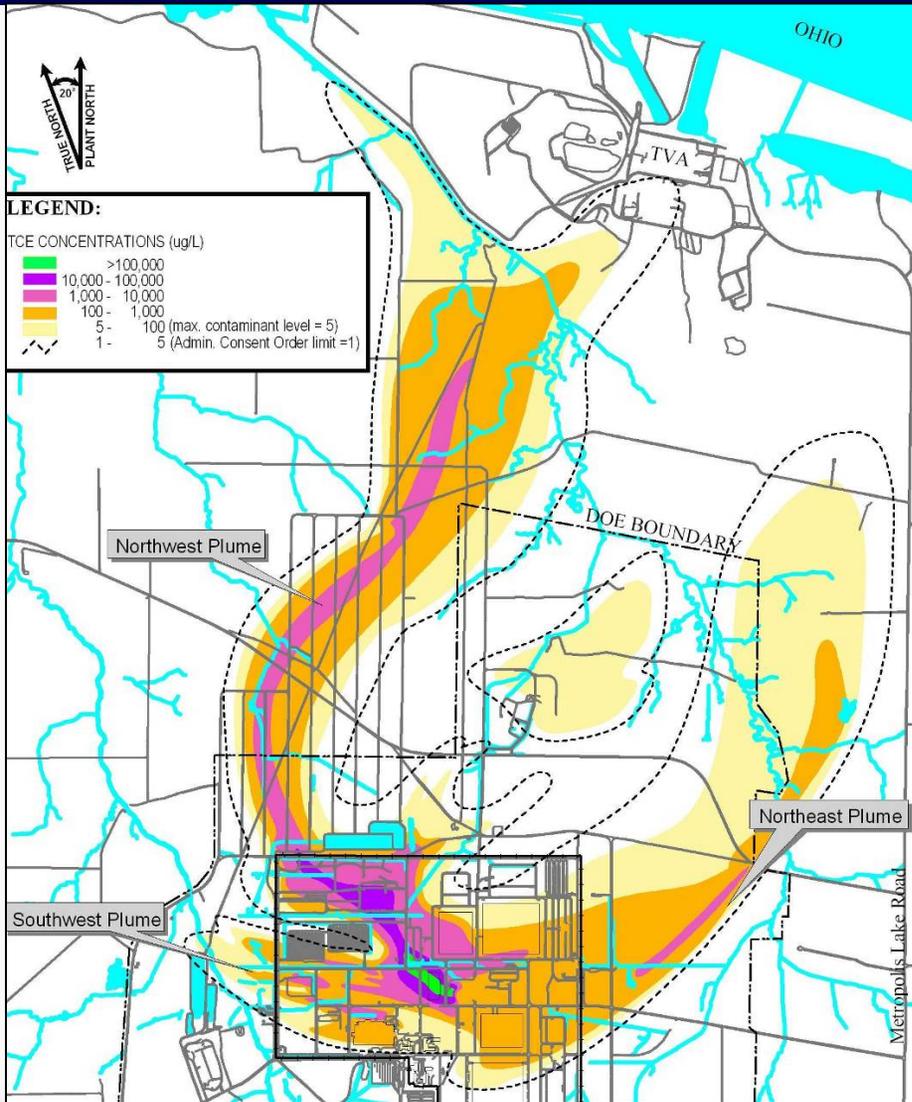
- In 1988, groundwater contamination discovered beyond DOE property boundary
- Main contaminant is the degreaser TCE

TCE contamination plumes at PGDP

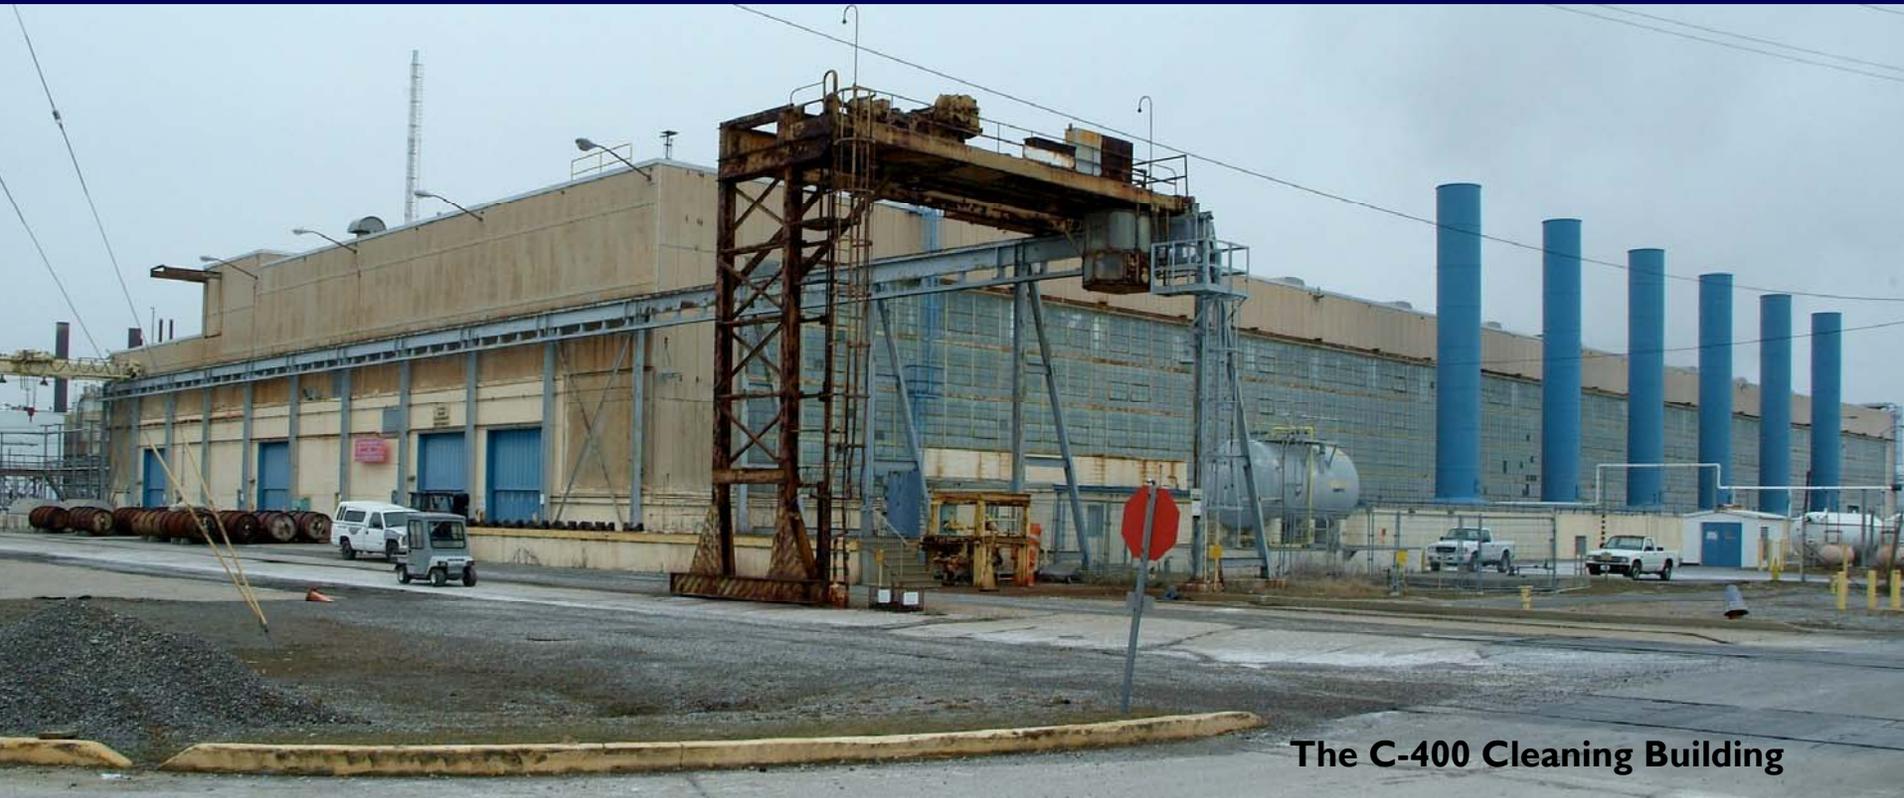
The C-400 Cleaning Building

- Largest contamination source is the C-400 Cleaning Building, located near the center of the plant
- In 2005, DOE signed a Record of Decision to use electrical resistance heating to vaporize TCE, which then will be collected by vacuum pumps

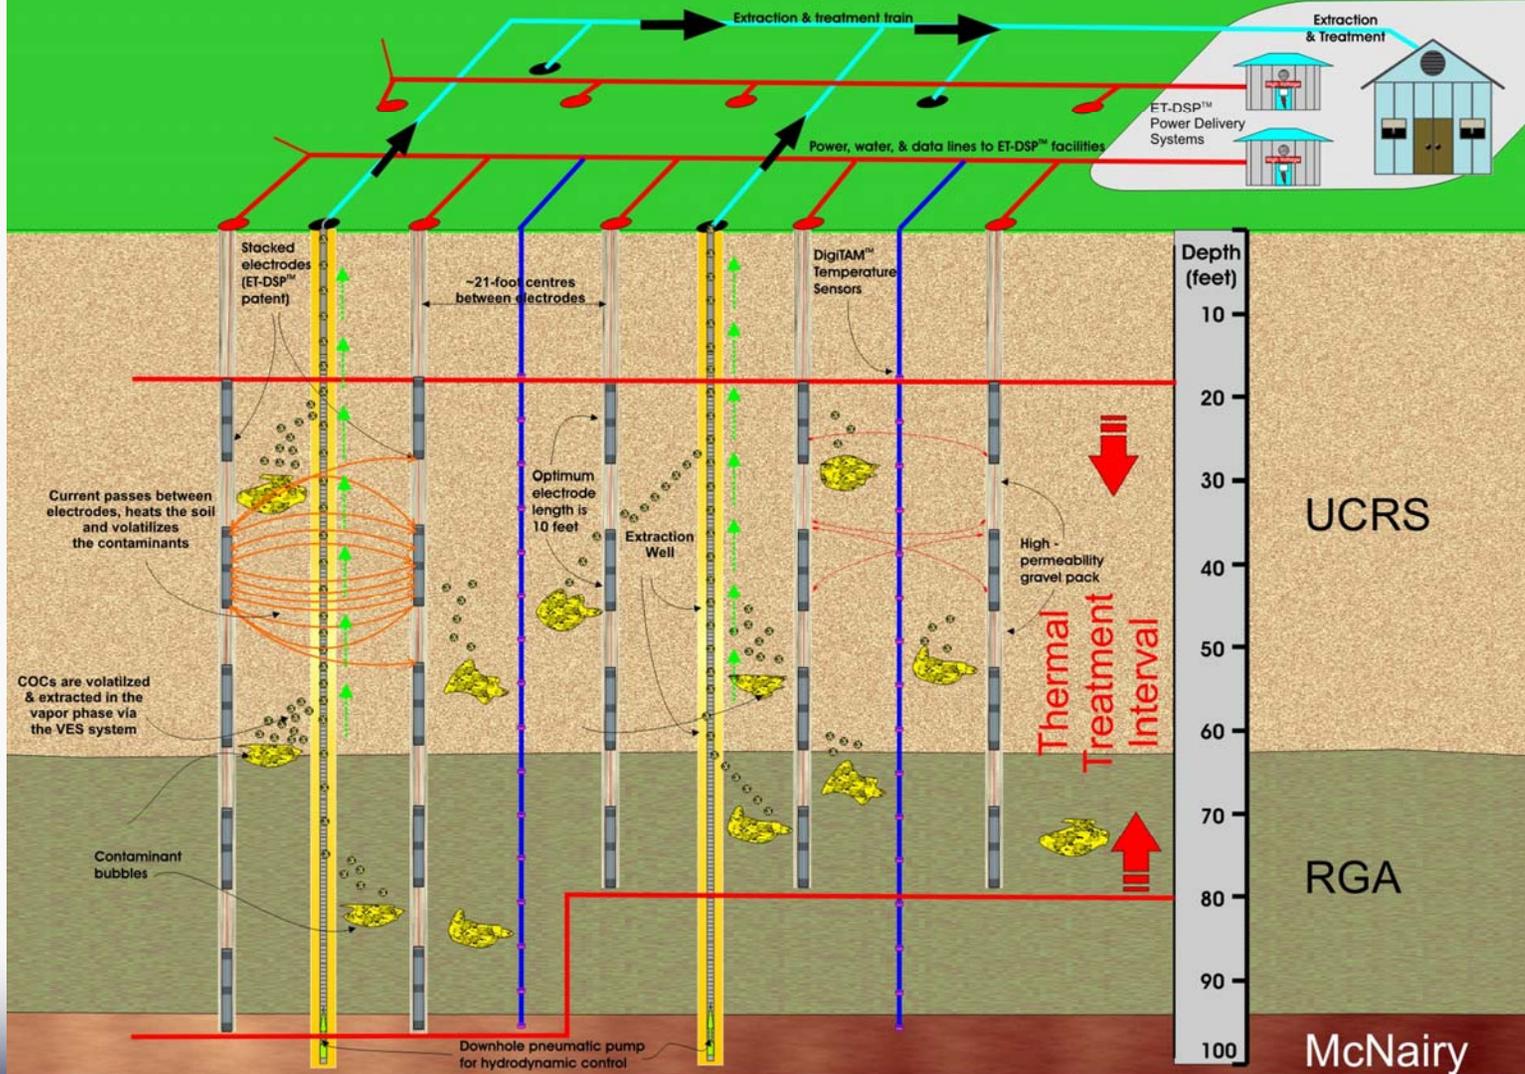
Cross Section of Conceptual Design for the Paducah Site

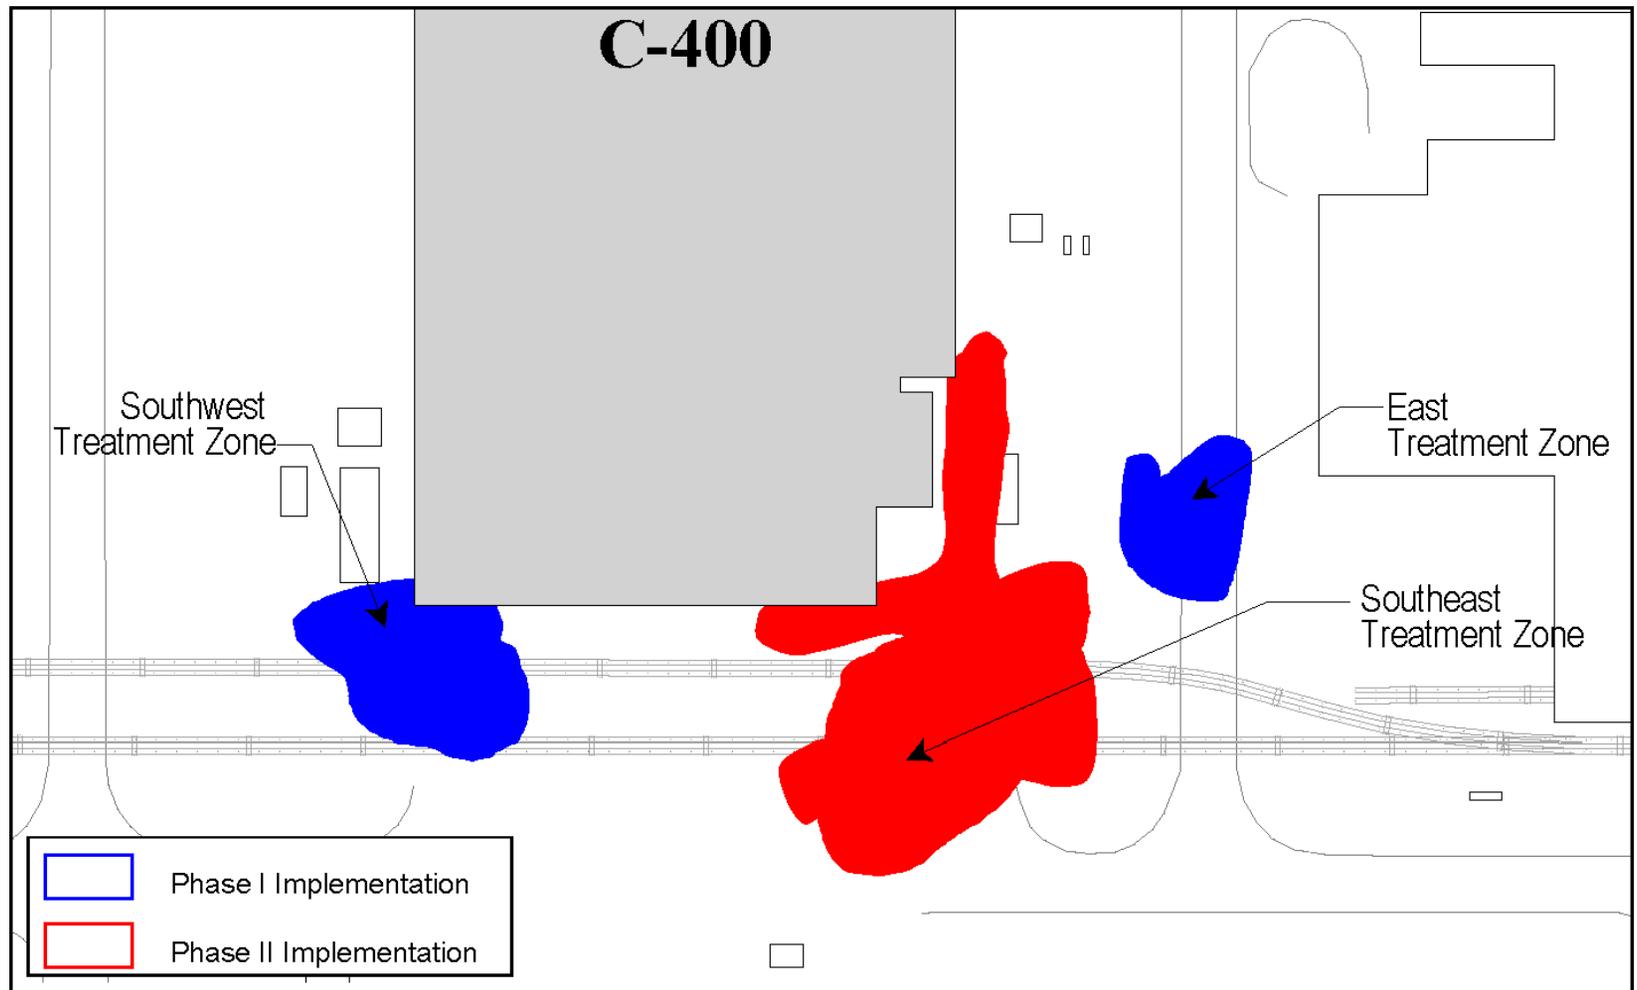
Here you see the highest concentrations of TCE on the site. We will be treating the area in two phases. The blue zones are Phase, I which is now under construction.

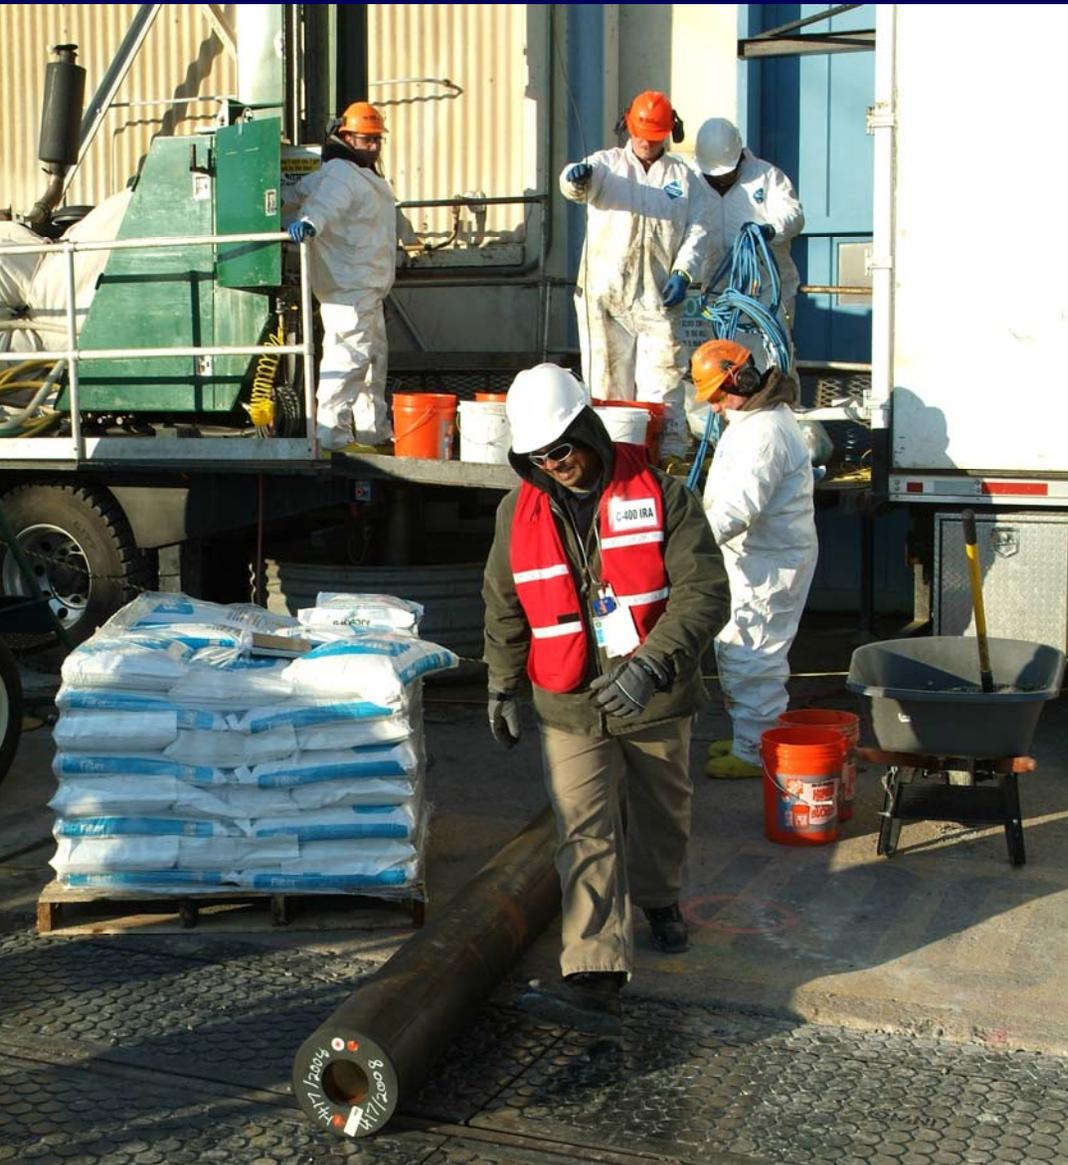
- Drilling and electrode insertion began December 10, 2008

Workers prepare to hoist an electrode to place in a boring at C-400.

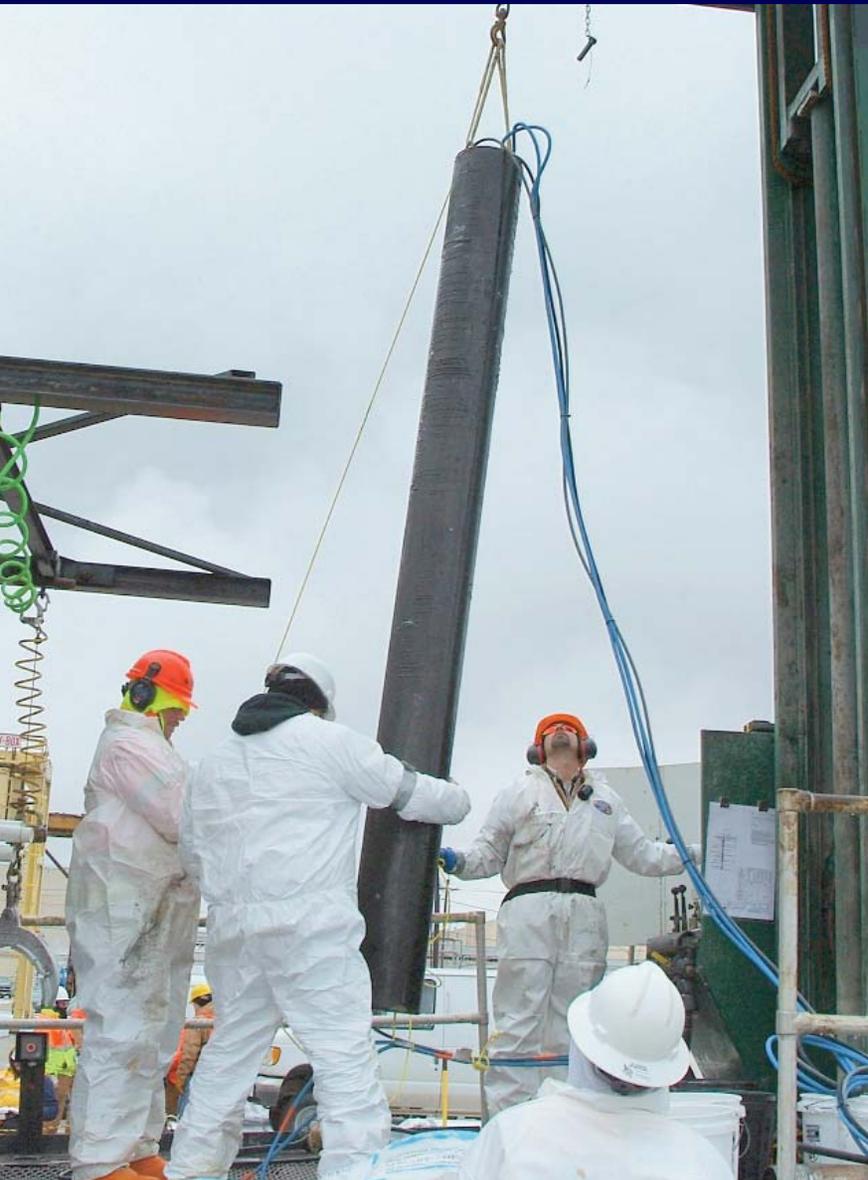
An electrode is inserted into a boring during mid-December 2008.

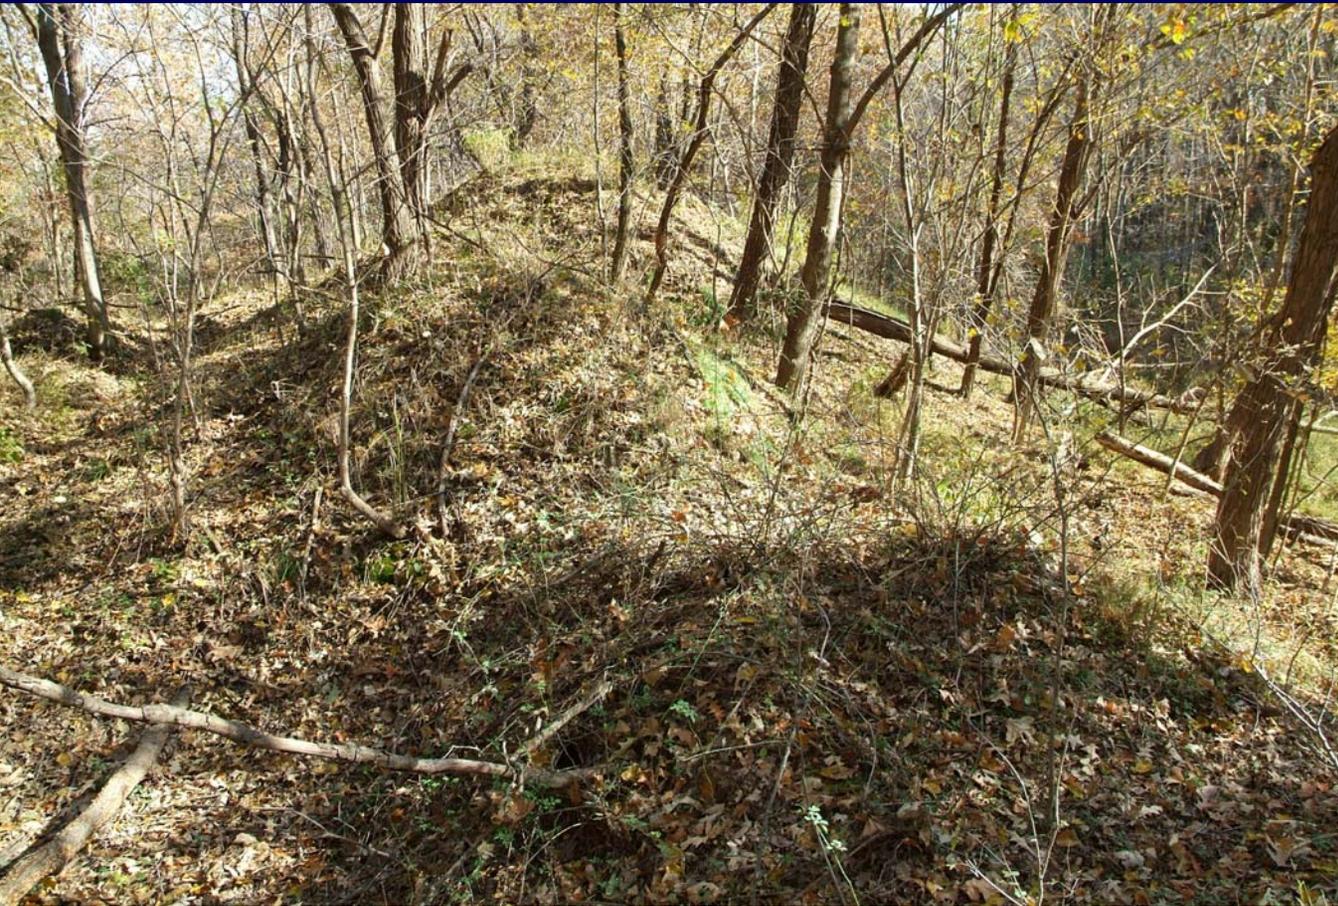
- In November 2006, technicians performing a routine survey of DOE property discovered elevated levels of contamination in soil piles outside the security fence

One of the soil areas on the east side of the plant.

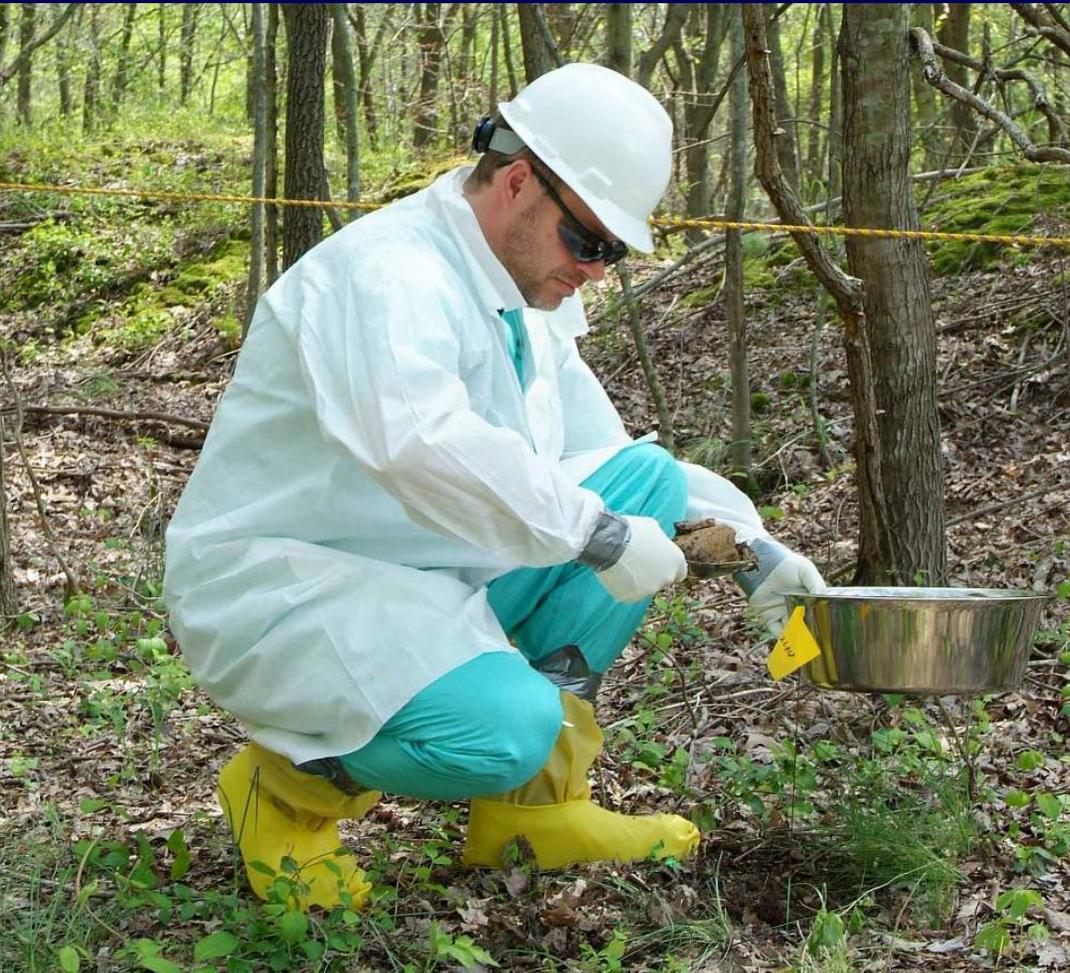
A technician takes a soil sample.

- Piles resulted from maintenance actions, such as creek dredging, in the 1970s and 1980s
- 104 soil areas and 51 concrete rubble areas
- Immediately upon discovery, DOE began a surveying effort to evaluate risk
 - 1st area sampling completed July 2007
 - Remaining areas divided into 3 phases for additional sampling

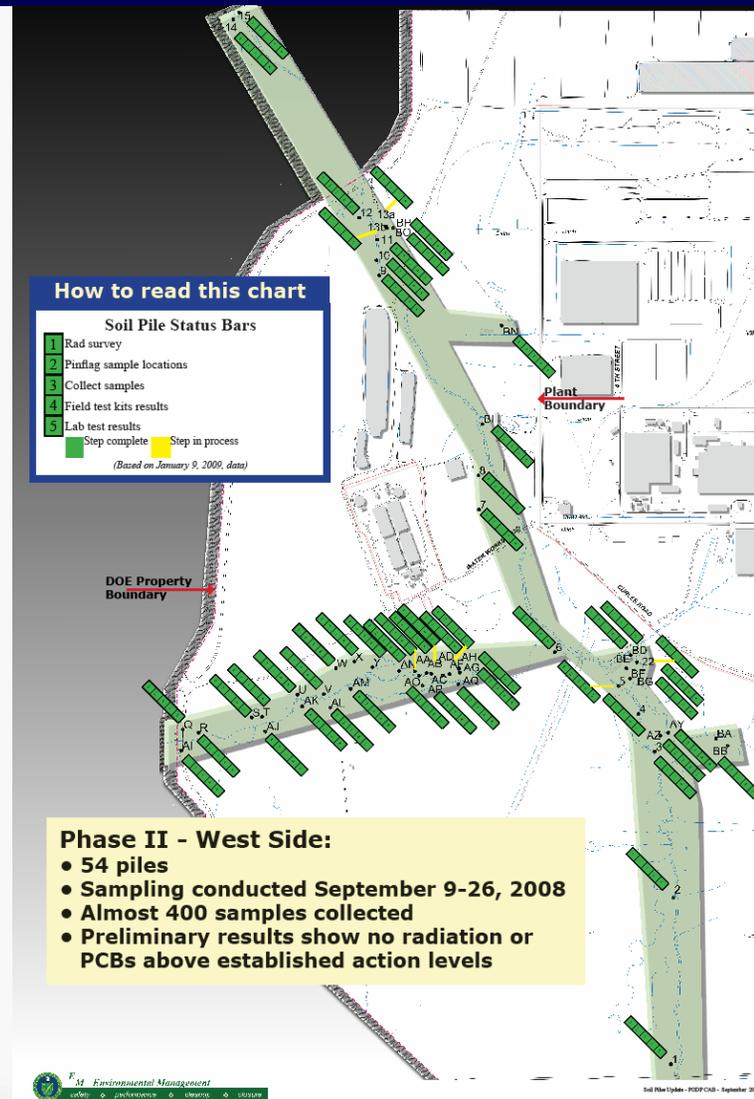
West Side Sampling

- West side soil pile sampling completed September 2008
 - Site Evaluation Report scheduled for February 2009
 - Results show no PCBs
 - Results show uranium at or below background level

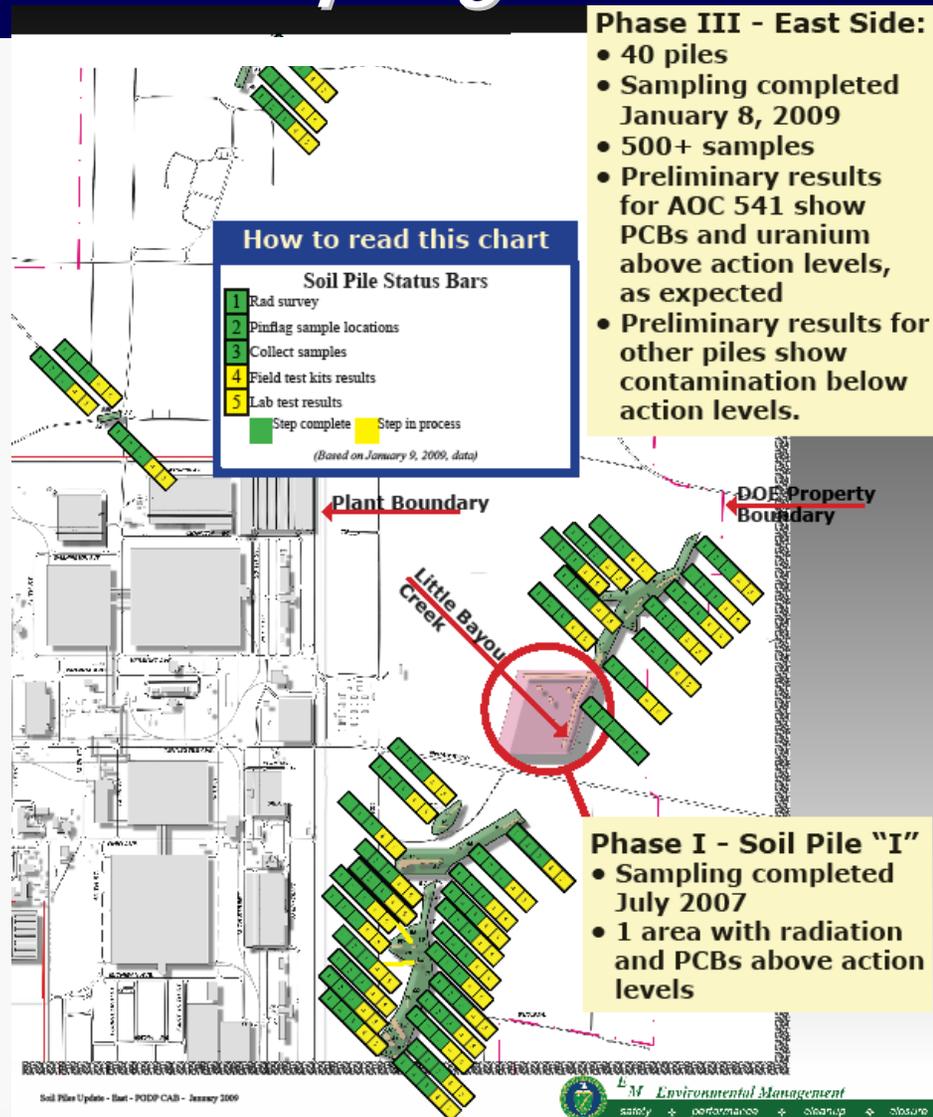
East Side Sampling

- All sampling completed
- Preliminary data currently under review

Phase III - East Side:

- 40 piles
- Sampling completed January 8, 2009
- 500+ samples
- Preliminary results for AOC 541 show PCBs and uranium above action levels, as expected
- Preliminary results for other piles show contamination below action levels.

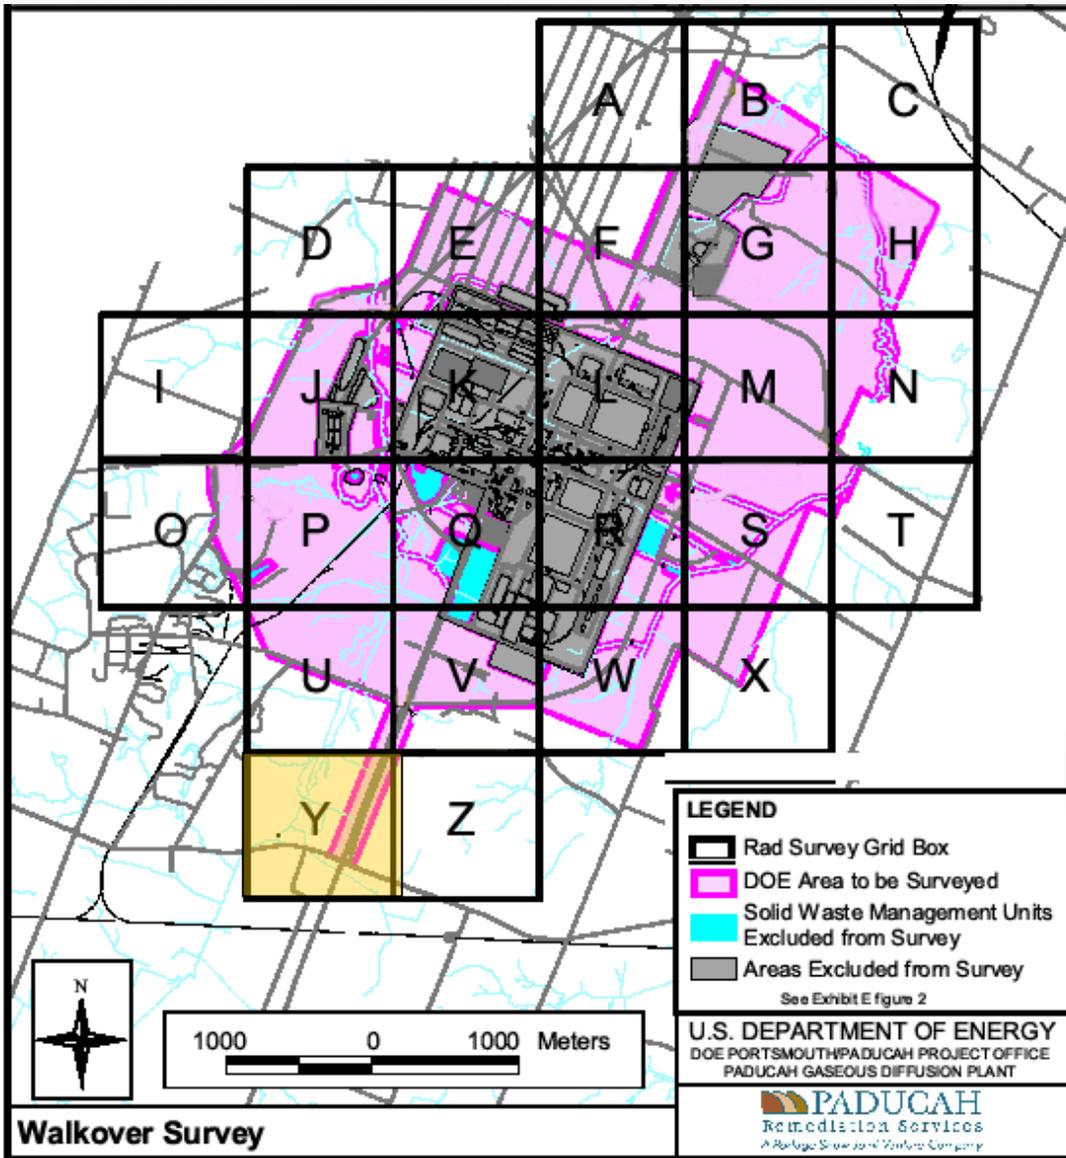
Grid completed

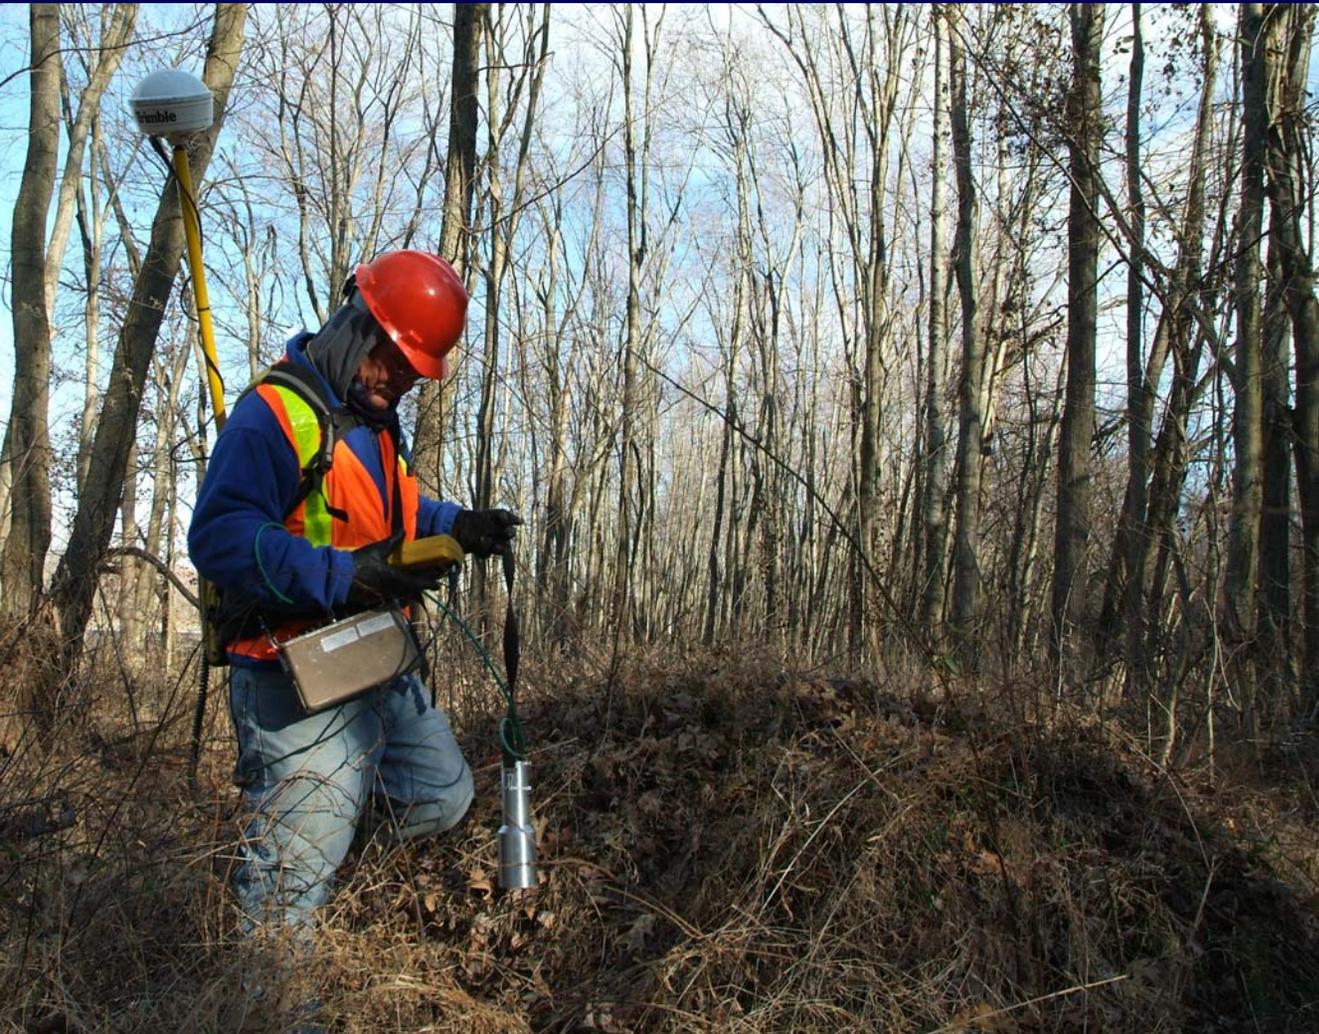
- Radiological survey will be performed on any area where materials appear to have been placed or removed
- 100% visual inspection of ~2,500 acres

A radiation control technician performs a radiological survey in Grid Y earlier this week.

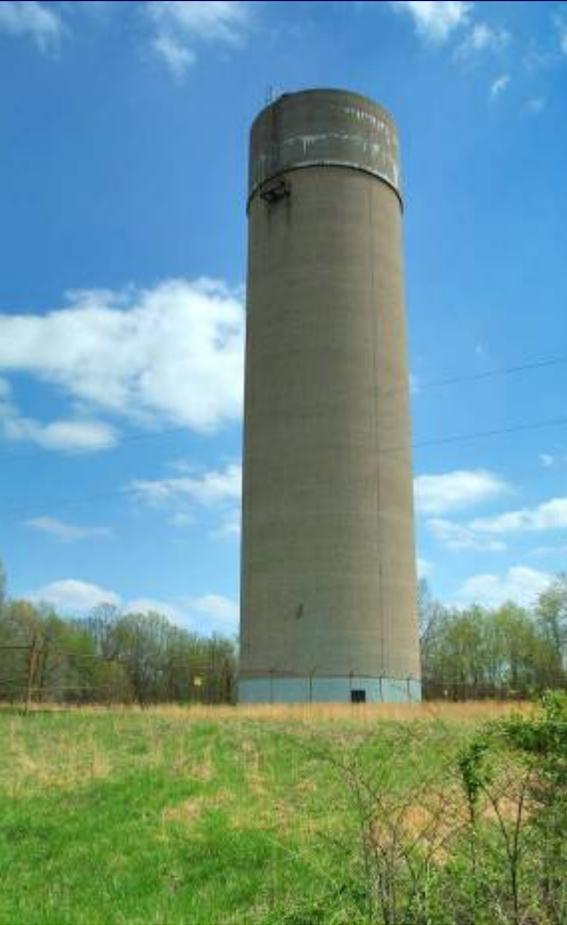
North Tower

- 66-year-old towers once used for water storage at Kentucky Ordnance Works
- Later used to support plant fire suppression system
- Demolition scheduled in February 2009
- Metal and concrete being salvaged and reused
